Historic Structures Report
Architectural & Historical Data Section

Clubhouse, Brown Cottage, Moorhead Cottage,
and Clubhouse Annex

**SOUTH FORK FISHING
& HUNTING CLUB**

By
Landmarks Design Associates, Architects
and
Wallace, Roberts & Todd

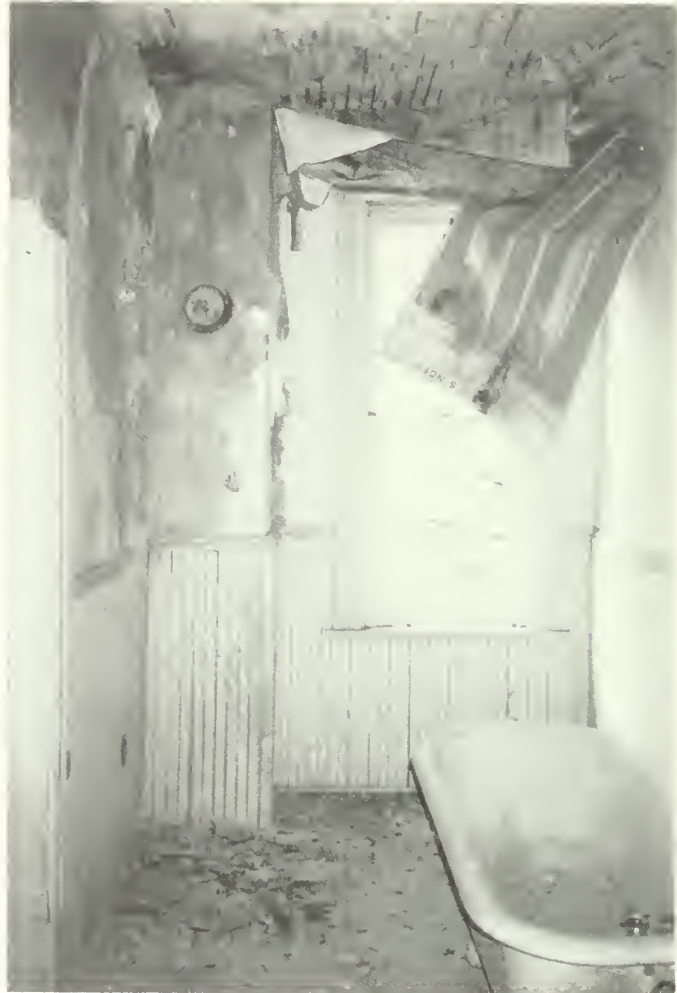
Photo E-48 Room 203, looking south. The bathtub stored in this room is not original to the room.
Brown Cottage 1992

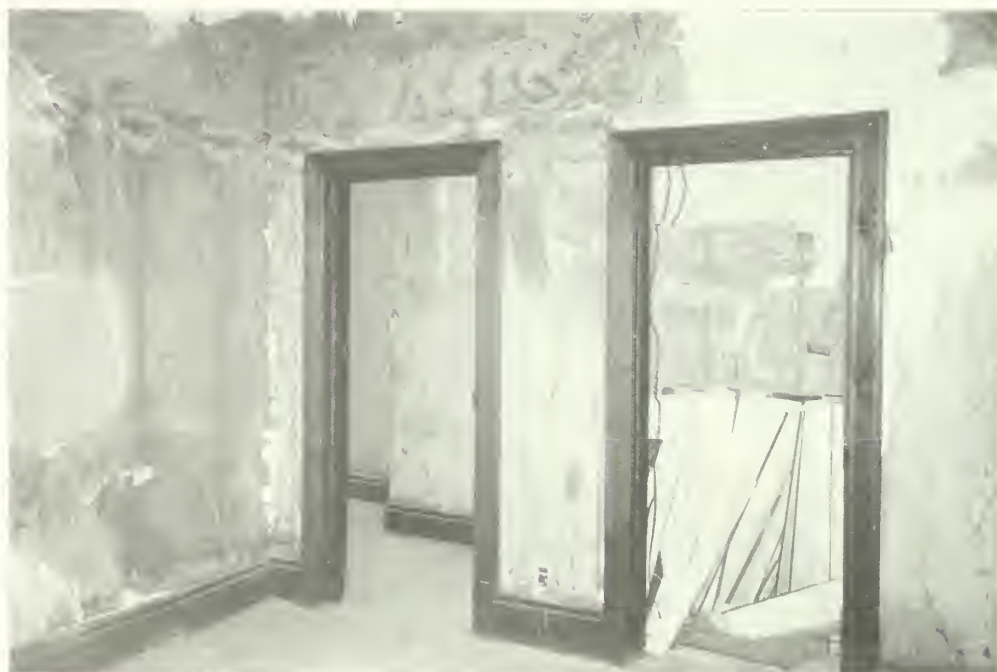
Photo E-56 Northwest corner of room 302. Ghost of former doorway is faintly visible in wall in hallway beyond left doorway.
Brown Cottage 1992

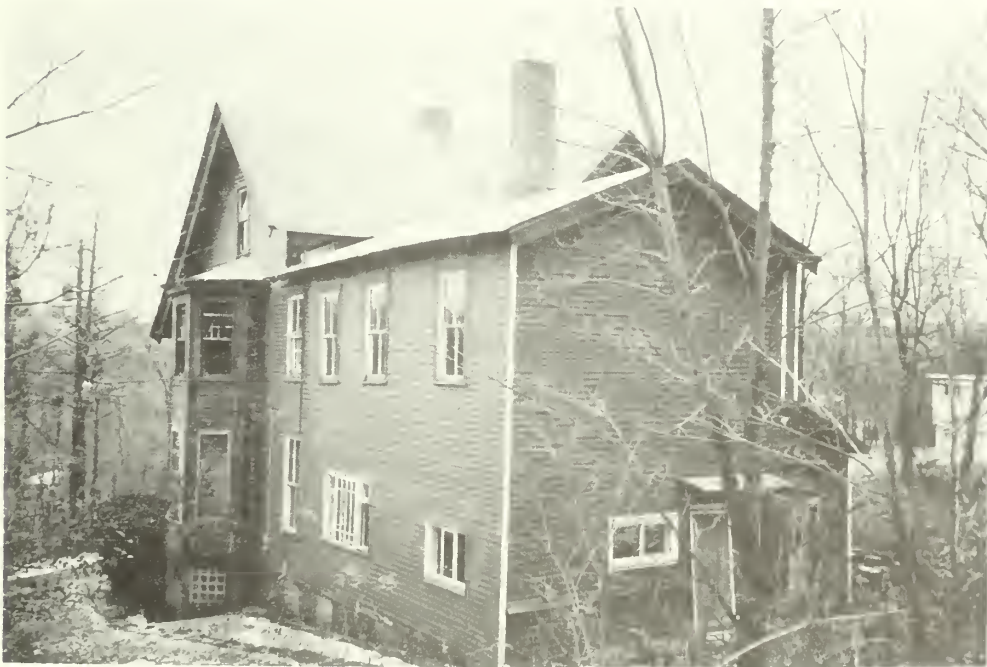
E-63 North elevation and partial west elevation.
Moorhead Cottage 1992

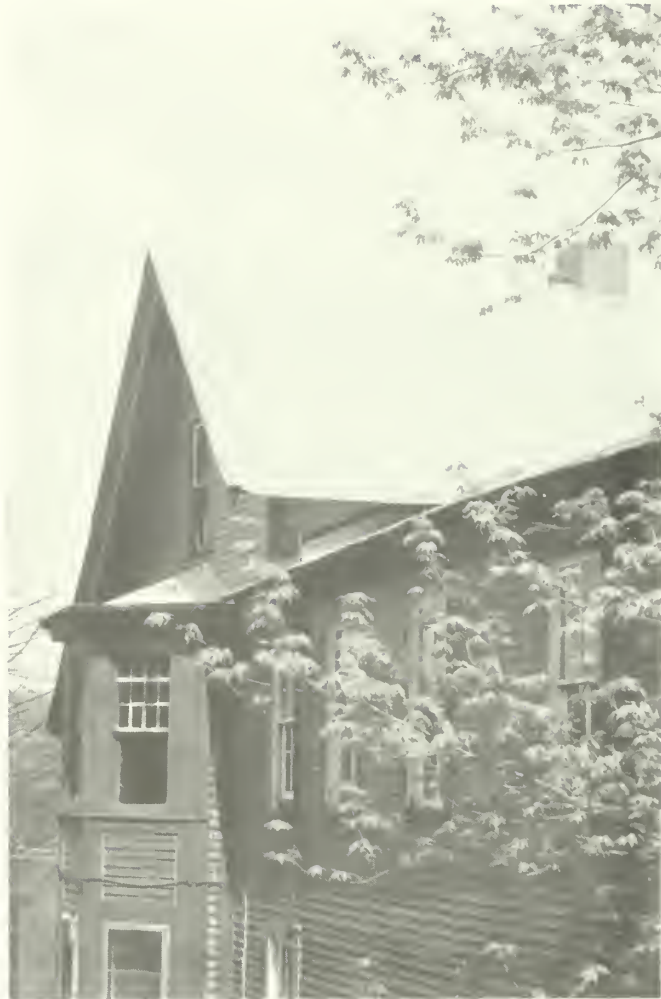
Photo E-64 North facade showing original wood shiplap siding visible at the eave of the main roof and in the return of the bay area.
Moorhead Cottage 1992

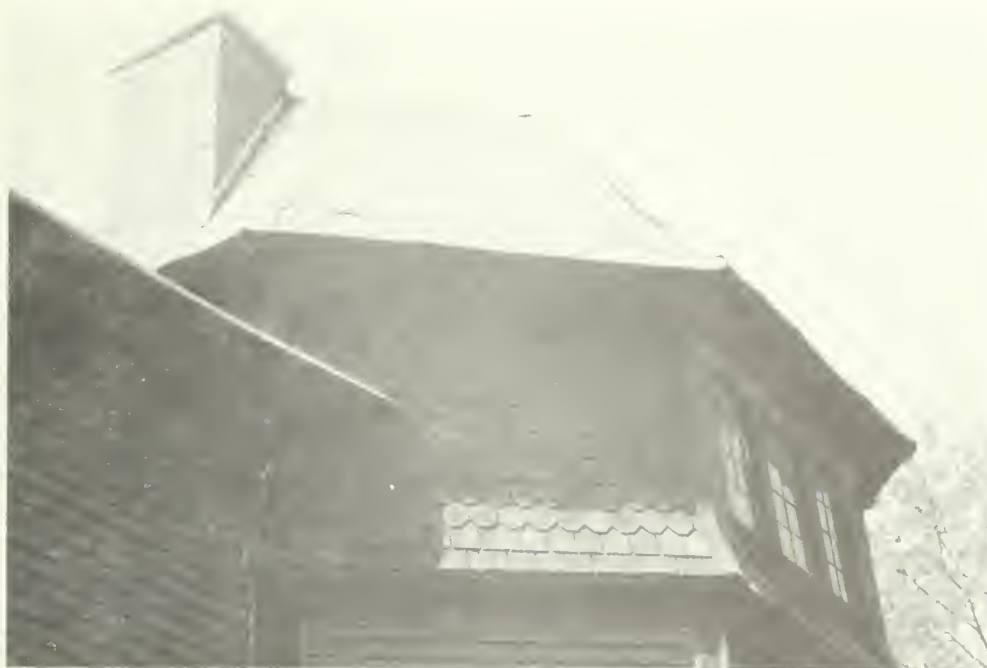
E-65 View of southwest wall of tower showing original wood shingles at third floor.
Moorhead Cottage 1992

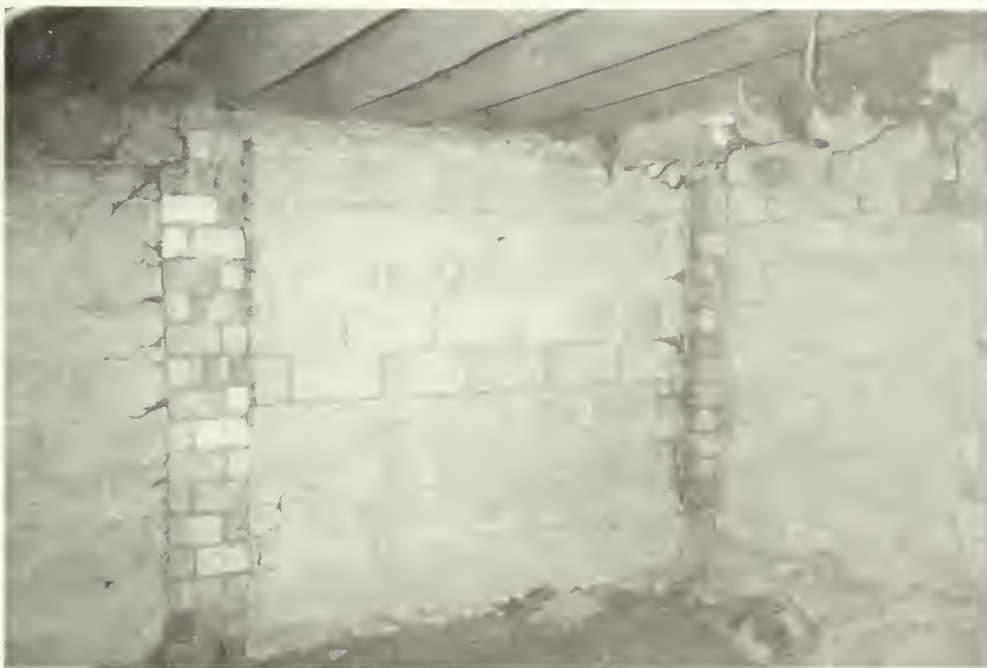
E-70 Northeast corner of room B01 indicating masonry pier and infill structural system.
Moorhead Cottage 1992

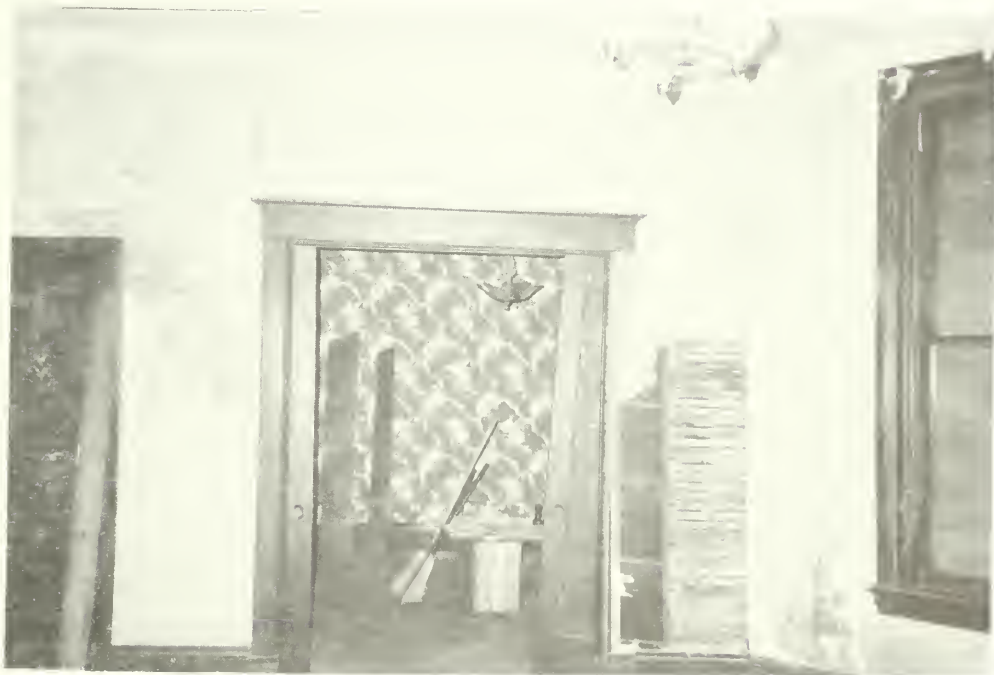
c E-73 North wall of room 102 showing early twentieth century pocket doors and alterations to wall.
Moorhead Cottage 1992

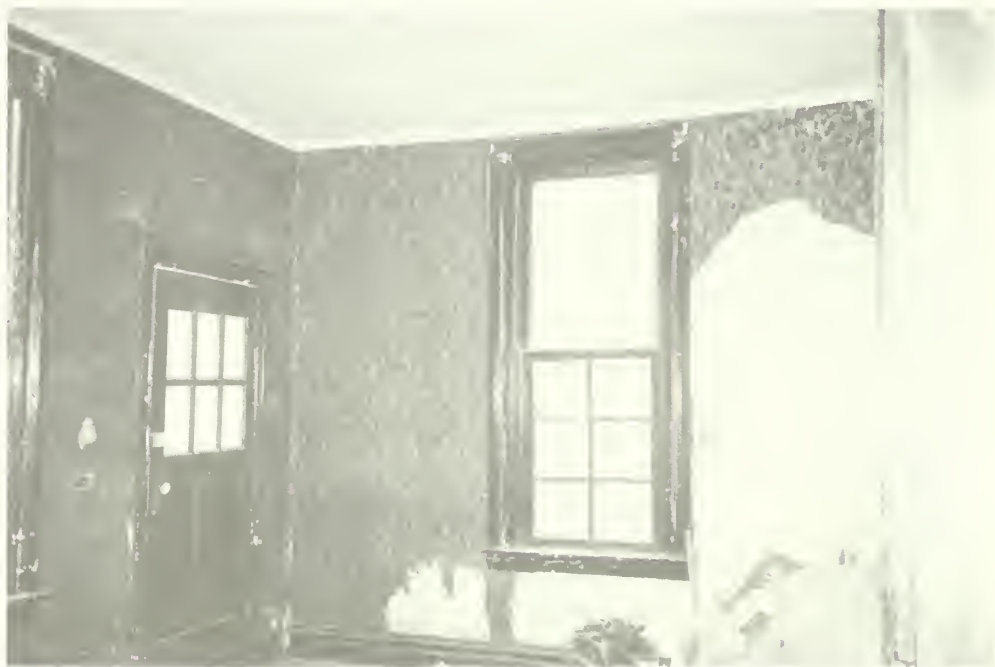
Photo E-75 Southwest view of room 103 showing window and door alterations.
Moorhead Cottage 1992

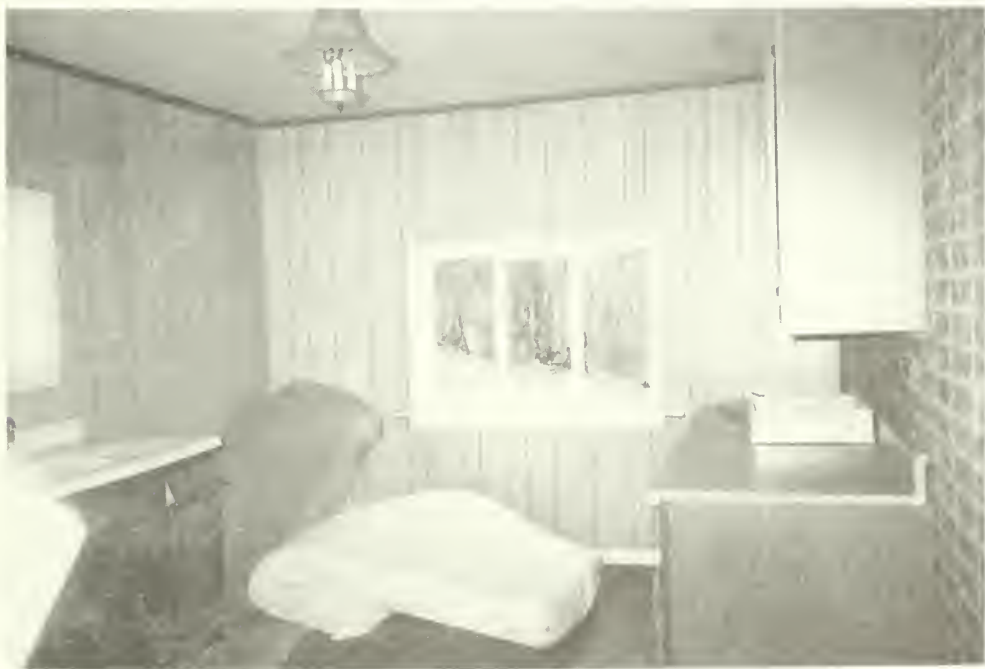
Photo E-79 South wall of room 106 showing paneling at stairway installed from another location. The window to the right of the stair replaces an original door. Moorhead Cottage 1992

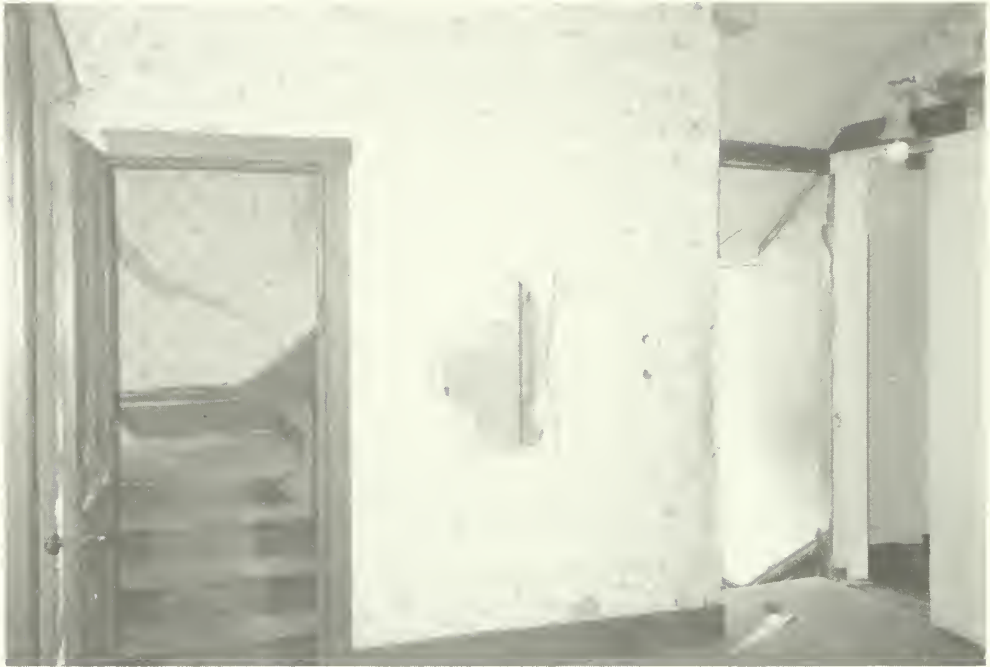
Photo E-81 View of enclosure added over main stair at second floor.
Moorhead Cottage 1992

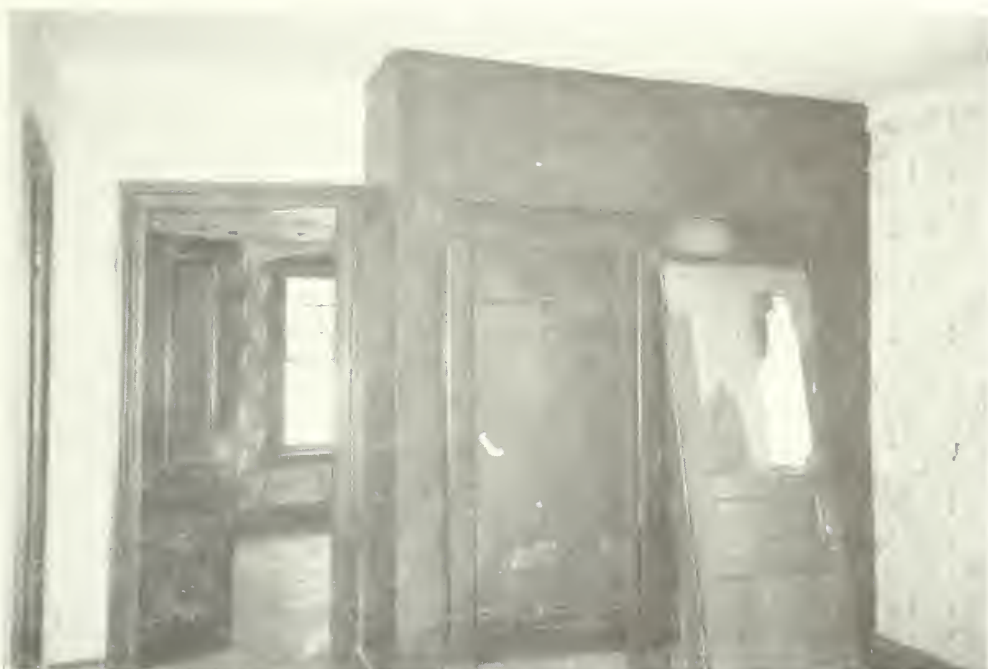
E-86 East wall of room 203 with view through doorway to room 202. The closet is an addition to the room.
Moorhead Cottage 1992

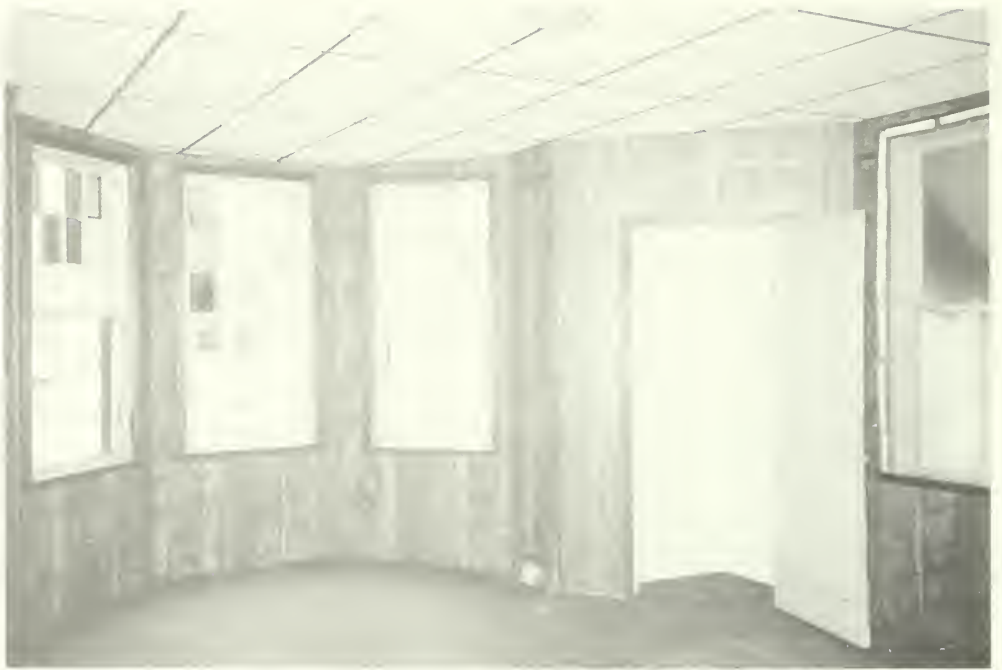
Photo E-88 North bay and northeast corner of room 204, showing colored glass in upper sashes of bay and modern paneling. Moorhead Cottage 1992

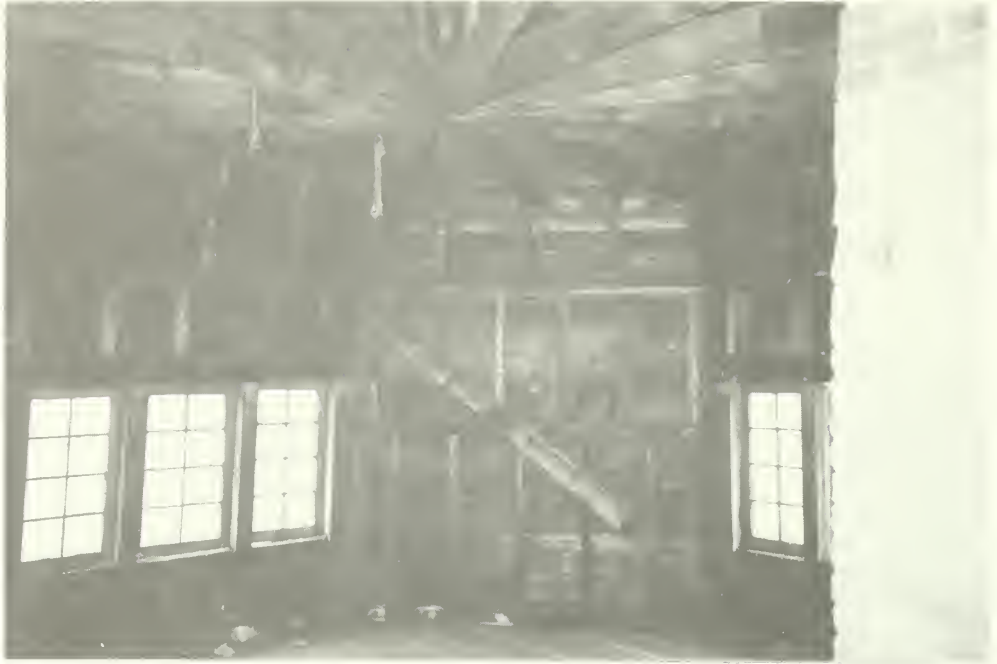
Photo E-91 South wall of room 304 with view to hall 300. Closet to the left is a later addition.
Moorhead Cottage 1992

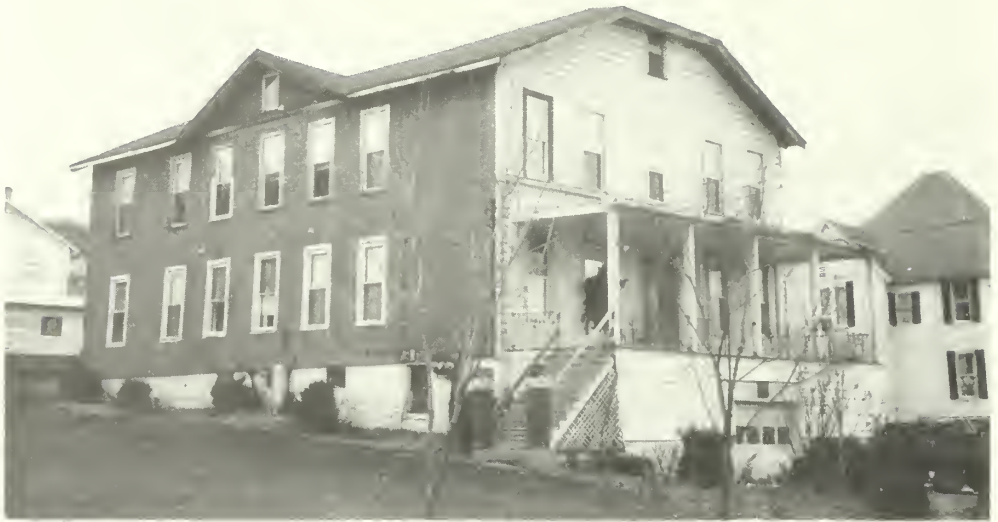
Photo E-94 South and east elevations.
Clubhouse Annex 1992

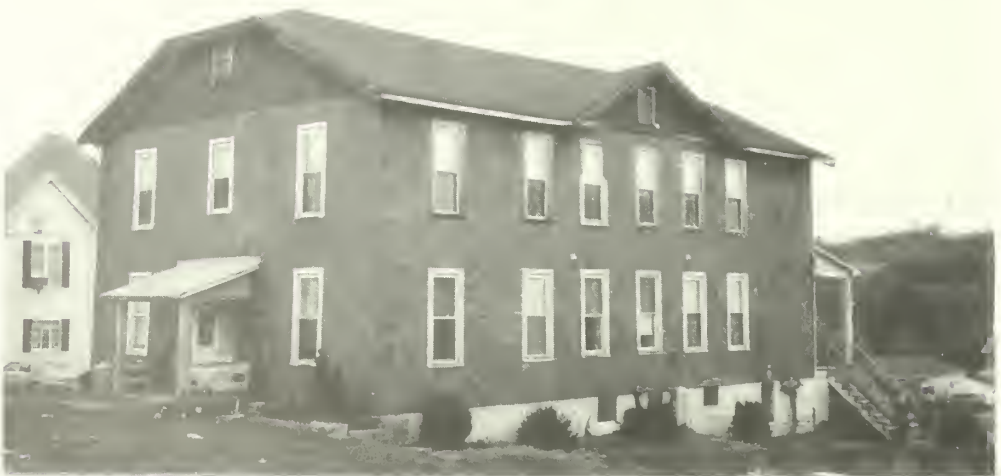
Photo E-95 West and south elevations.
Clubhouse Annex 1992

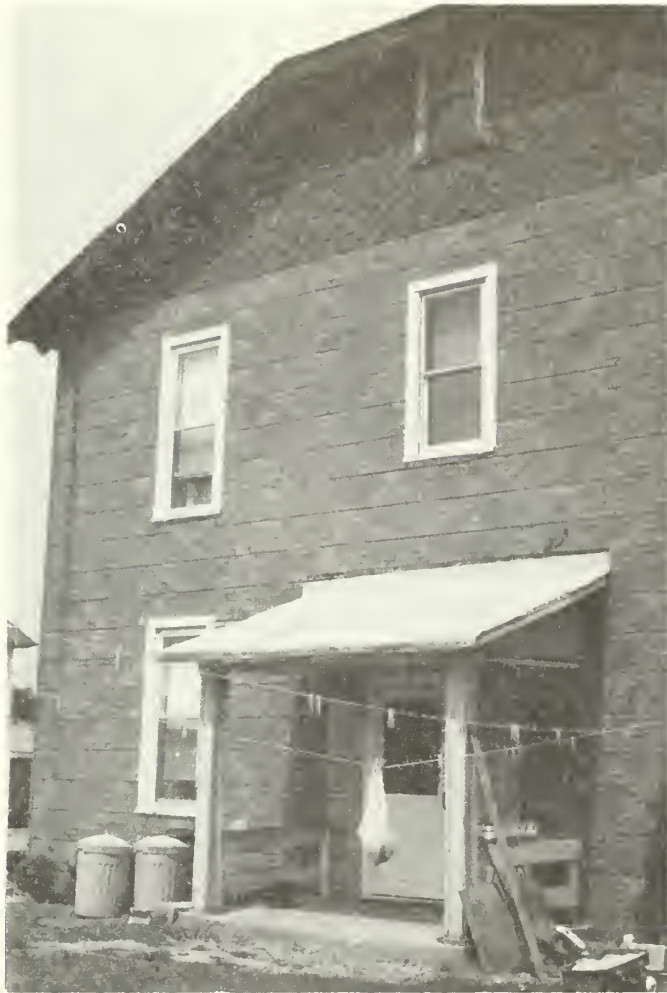
Photo E-96 Detail of west elevation showing original wood siding flanking rear door.
Clubhouse Annex 1992
